**FINAL**  
**Coal Ash Impoundment –**  
**Specific Site Assessment Report**  
**Westar Energy**  
Jeffrey Energy Center

Submitted to:  
**Lockheed-Martin Corporation**  
2890 Wood Bridge Avenue  
Building 209 BAYF  
Edison, NJ 08837

Submitted by:  
**GEI Consultants, Inc.**  
6950 South Potomac Street, Suite 300  
Centennial, CO 80112

September 2009  
Project 091330

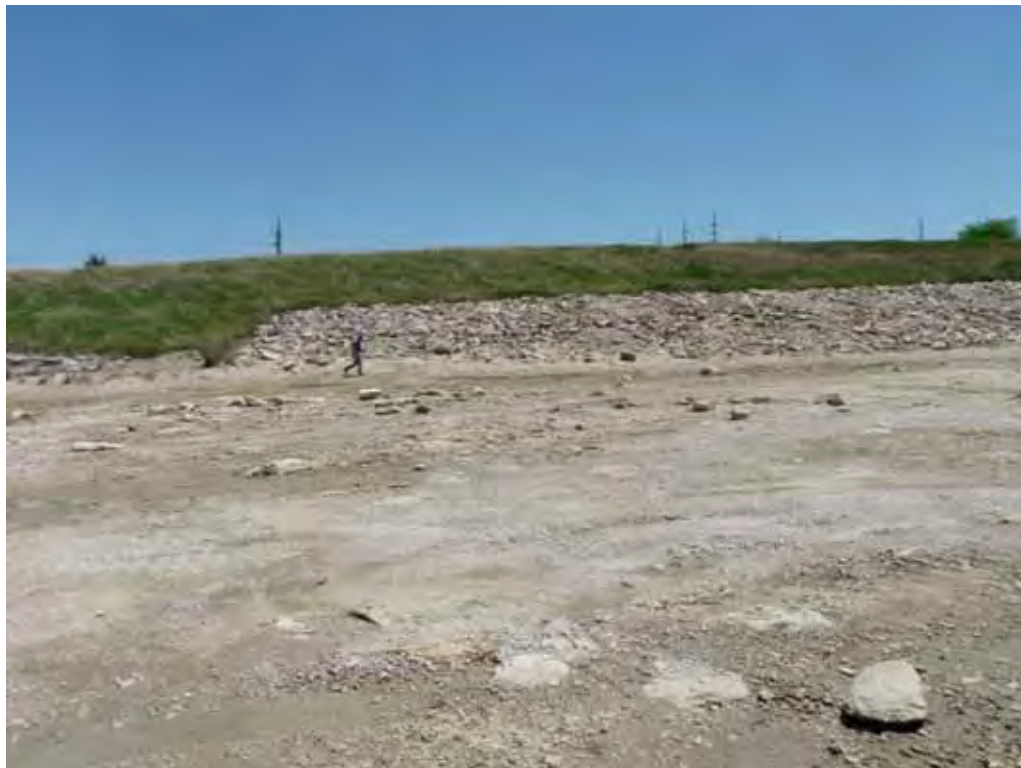
**Photo 7 - Emergency Spillway – Looking at right side slope of the spillway along approach channel.**

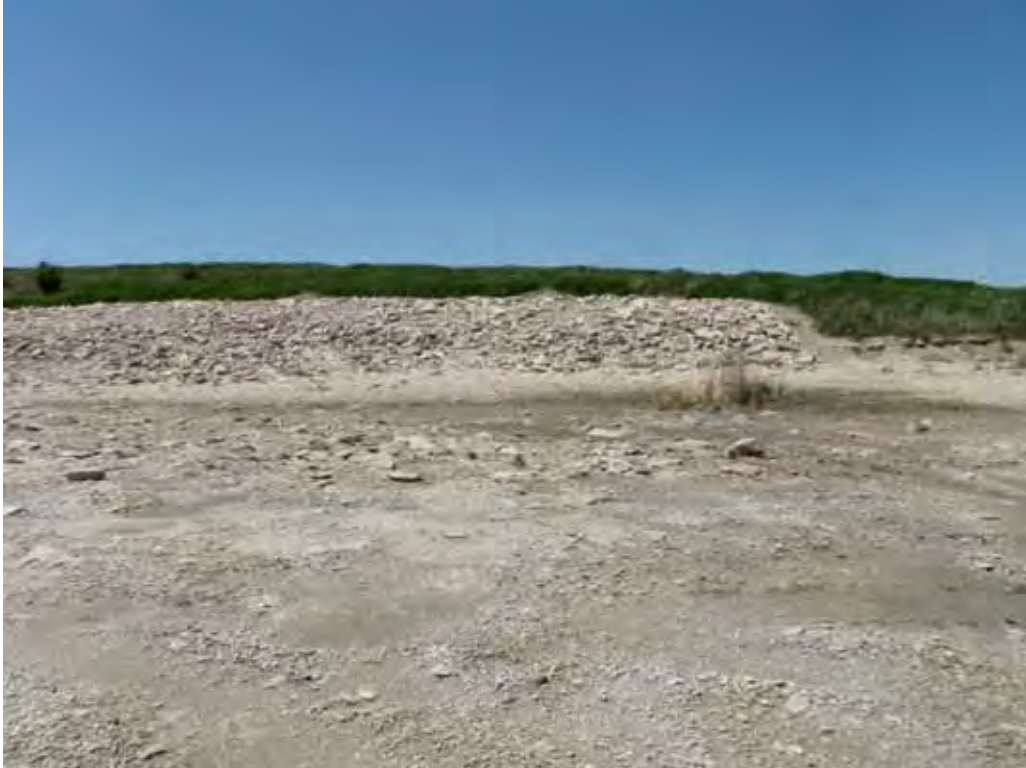
**Photo 8 - Emergency Spillway – Looking downstream, towards control crest from waters edge.**

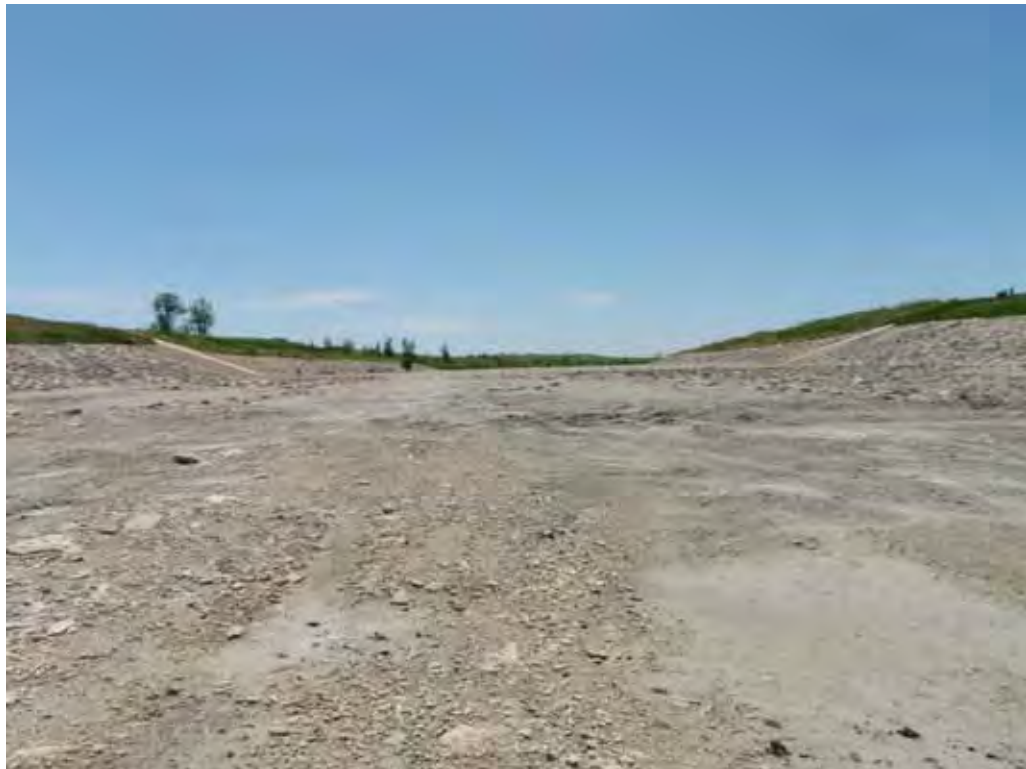
The limestone riprap both upstream and downstream of the concrete control crest showed extensive deterioration along the entire length of the control crest (Photos 1 – 4). Minor concrete spalling was also observed at a few locations on the top of the concrete control crest. The approach channel to the emergency spillway was also observed to have extensive riprap deterioration showing significant variability in riprap size (Photos 5-8). The riprap lining on the channel downstream of the control crest showed less deterioration and more consistent riprap sizes (Photo 9). Several small trees were observed at the exit of the riprap lined spillway channel which should be removed (Photo 10).

**Photo 9 - Emergency Spillway – Looking upstream near the end of the riprap lined channel. (Note: Small tree on left side slope of spillway)**

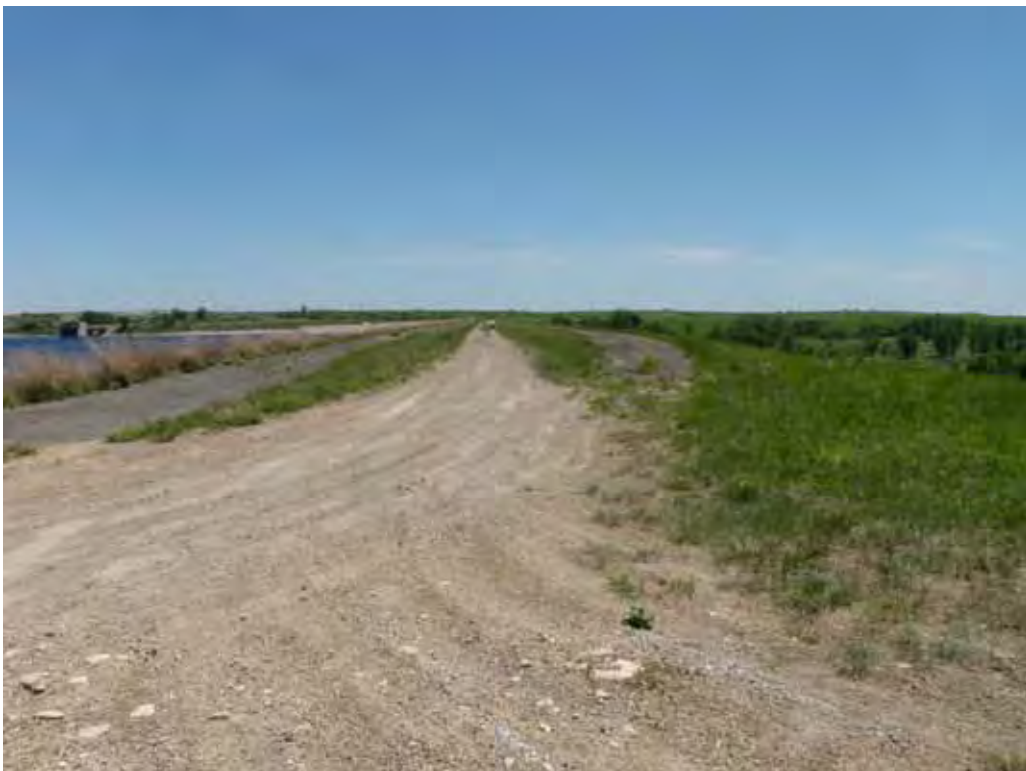
traverse the length of the dam (Photos 26 – 29). The dam crest also has some low lying grassy vegetation that should be cleared or maintained to an acceptable level to make visual inspection of the dam easier.

**Photo 27 - Dam Crest – Looking along dam crest from dam centerline to right abutment.**
